## Assessing causes and controls of bed erosion for the Drava River (between 0-236 rkm sections)

In the frame of project entitled Wise water management for the conservation of alluvial forest habitats along River Drava (LIFE17NAT/HU/000577)

September 2020

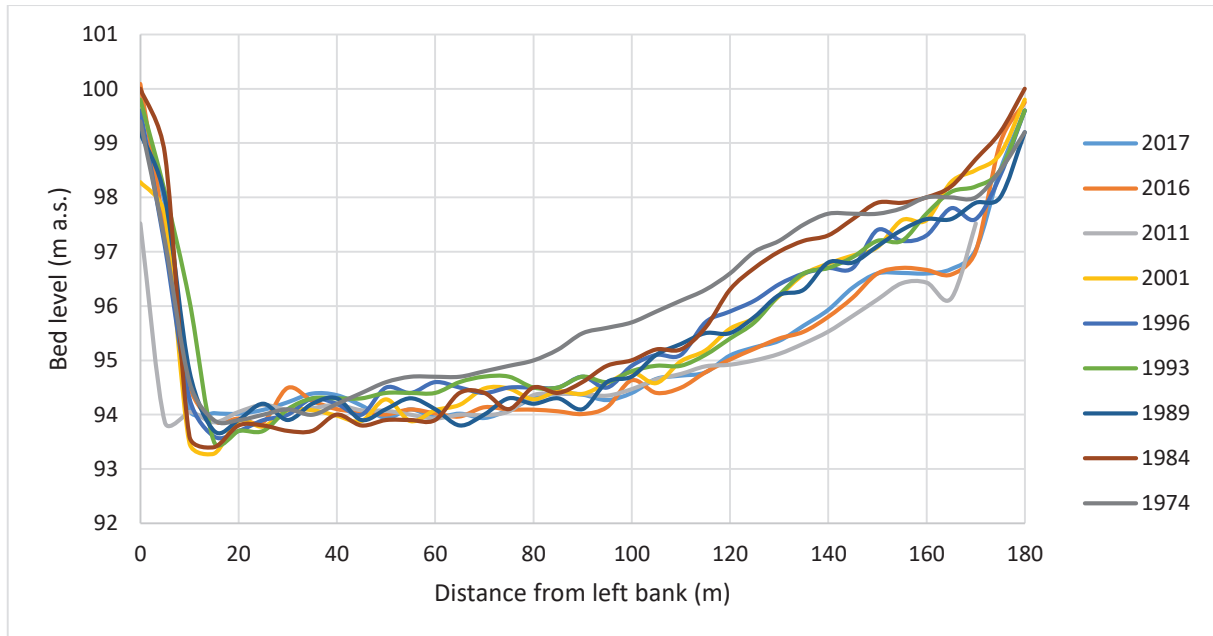
Figure 1: Geometric changes in the cross section of the "Barcs" station (154.10 rkm) between 1974 and 2017

The studies used both direct and indirect methods in order to determine the value of incision in a given period. Direct methods are based on the known volume of the excavated material or riverbed surveys (Figure 1). Indirect methods are based on the time series analysis of water levels. In this study, we performed a similar, but extensive analysis.

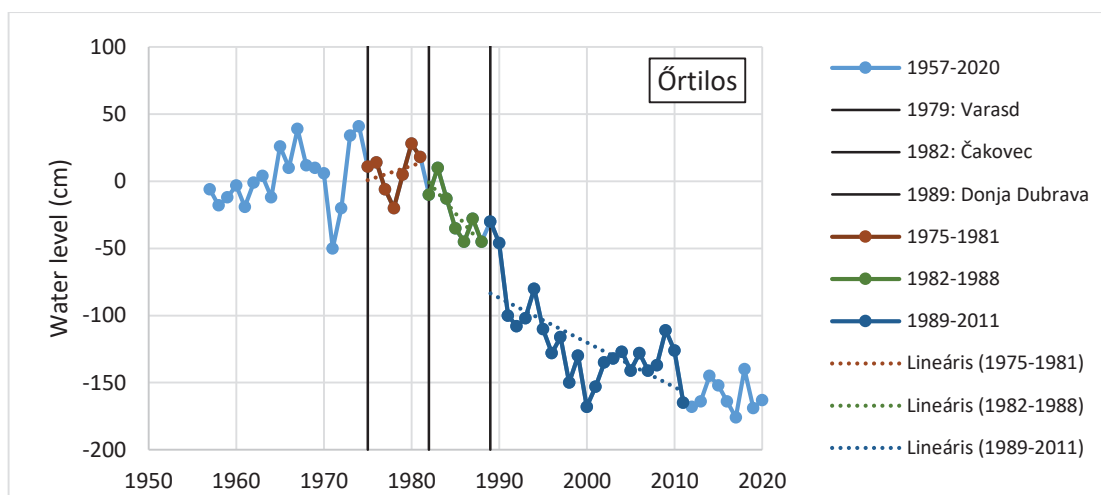
Figure 5: The effect of the Croatian HPPs according to the changes in low water levels in Őrtilos (235.90 rkm)

The HPPs also modify the hydrological regime. These effects cause other significant changes in the river morphology, such as narrowing and the simplification of the channel pattern. All the effects of the HPPs are spatially and temporally extensive, but not everlasting. The most significant changes occurred in Őrtilos (235.90 rkm), which is the closest section (of the investigated Drava section) to the three Croatian HPPs. The nearest, Donja Dubrava HPP is located only 10 kms upstream. It can be seen, that after putting the first two HPPs into operation, the new equilibrium state could be formed in 5-6 years, but after starting the operation of Donja Dubrava HPP, this process lasted a decade (1989-2000), during which, the riverbed deepened by ca. 140 cm. Note, that there are no other effects known at this station.

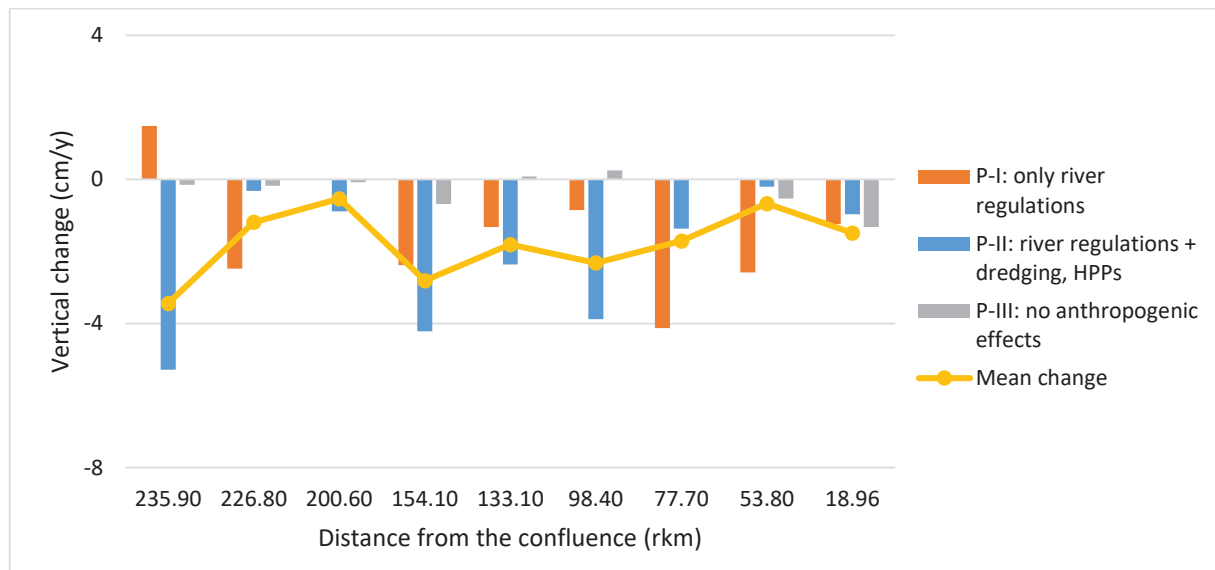
Figure 7: The intensity of vertical changes along the Lower Drava in periods determined by the anthropogenic effects. (Note: the length of the first period (P-I) varies at the different stations)

During the evaluative analysis, we determined three different periods depending on the major anthropogenic effect:

- **First period:** from the end of the 18th century until the first Croatian HPP (1975). During this period, only traditional river regulation measures were carried out. The natural equilibrium state of the Lower Drava had broken.

- **Second period:** from 1975 until 2002/2011 (downstream/upstream of Barcs), when the dredging activities discontinued. The effects of the different anthropogenic factors may cannot be distinguished.
- **Third period:** from 2003/2012 until nowadays. Analyzing the low water levels and the available riverbed geometry, we can conclude, that the vertical effects of the anthropogenic factors ceased and a new equilibrium state seems to be developing. However, it is important to note, that the analysis of this 10-20-years long period may not be representative.

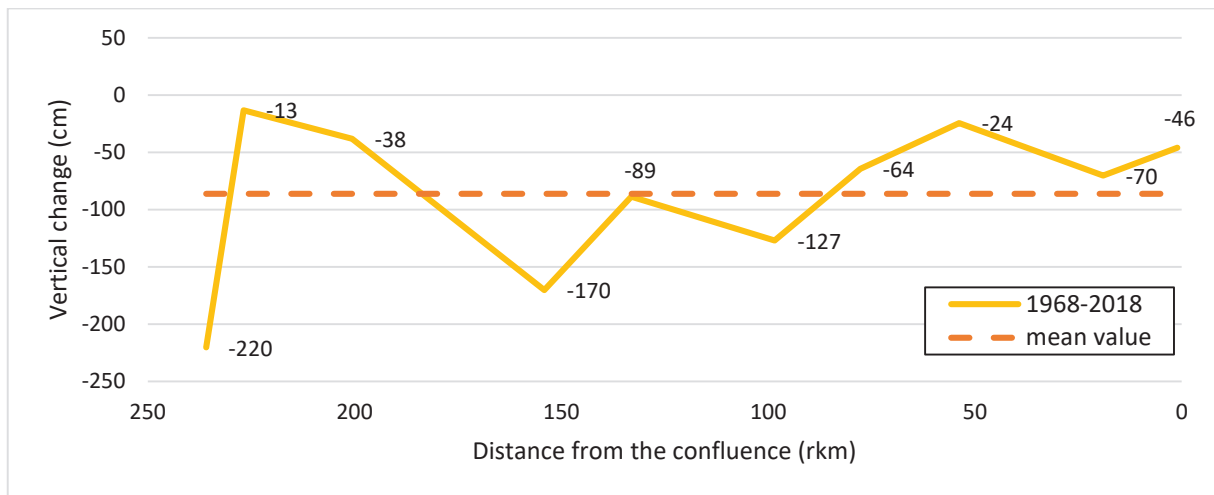
Figure 8: Bed level changes along the Drava River between 1968-2018

For the time period 1968-2018, the longitudinal profile of the vertical morphological changes could be produced as there was continuous data from each station. During this 50 years, the Drava deepened by ca. 86 cm. The most intensive incision (220 cm; 4.32 cm/y) occurred at the Órtilos station which is the closest to the Croatian HPPs. The rate of the incision is decreasing towards the confluence: it was 170 cm (3.33 cm/y) at Barcs and 64 cm (1.25 cm/y) at Drávaszabolcs.
